Special Investigation Report
Aircraft Separation Incidents at Hartsfield
Atlanta International Airport, Atlanta, Georgia
October 7, 1980

SPECIAL INVESTIGATION REPORT

**AIRCRAFT SEPARATION INCIDENTS
AT HARTSFIELD ATLANTA INTERNATIONAL AIRPORT
ATLANTA, GEORGIA
OCTOBER 7, 1980**

NTSB-SIR-81-6

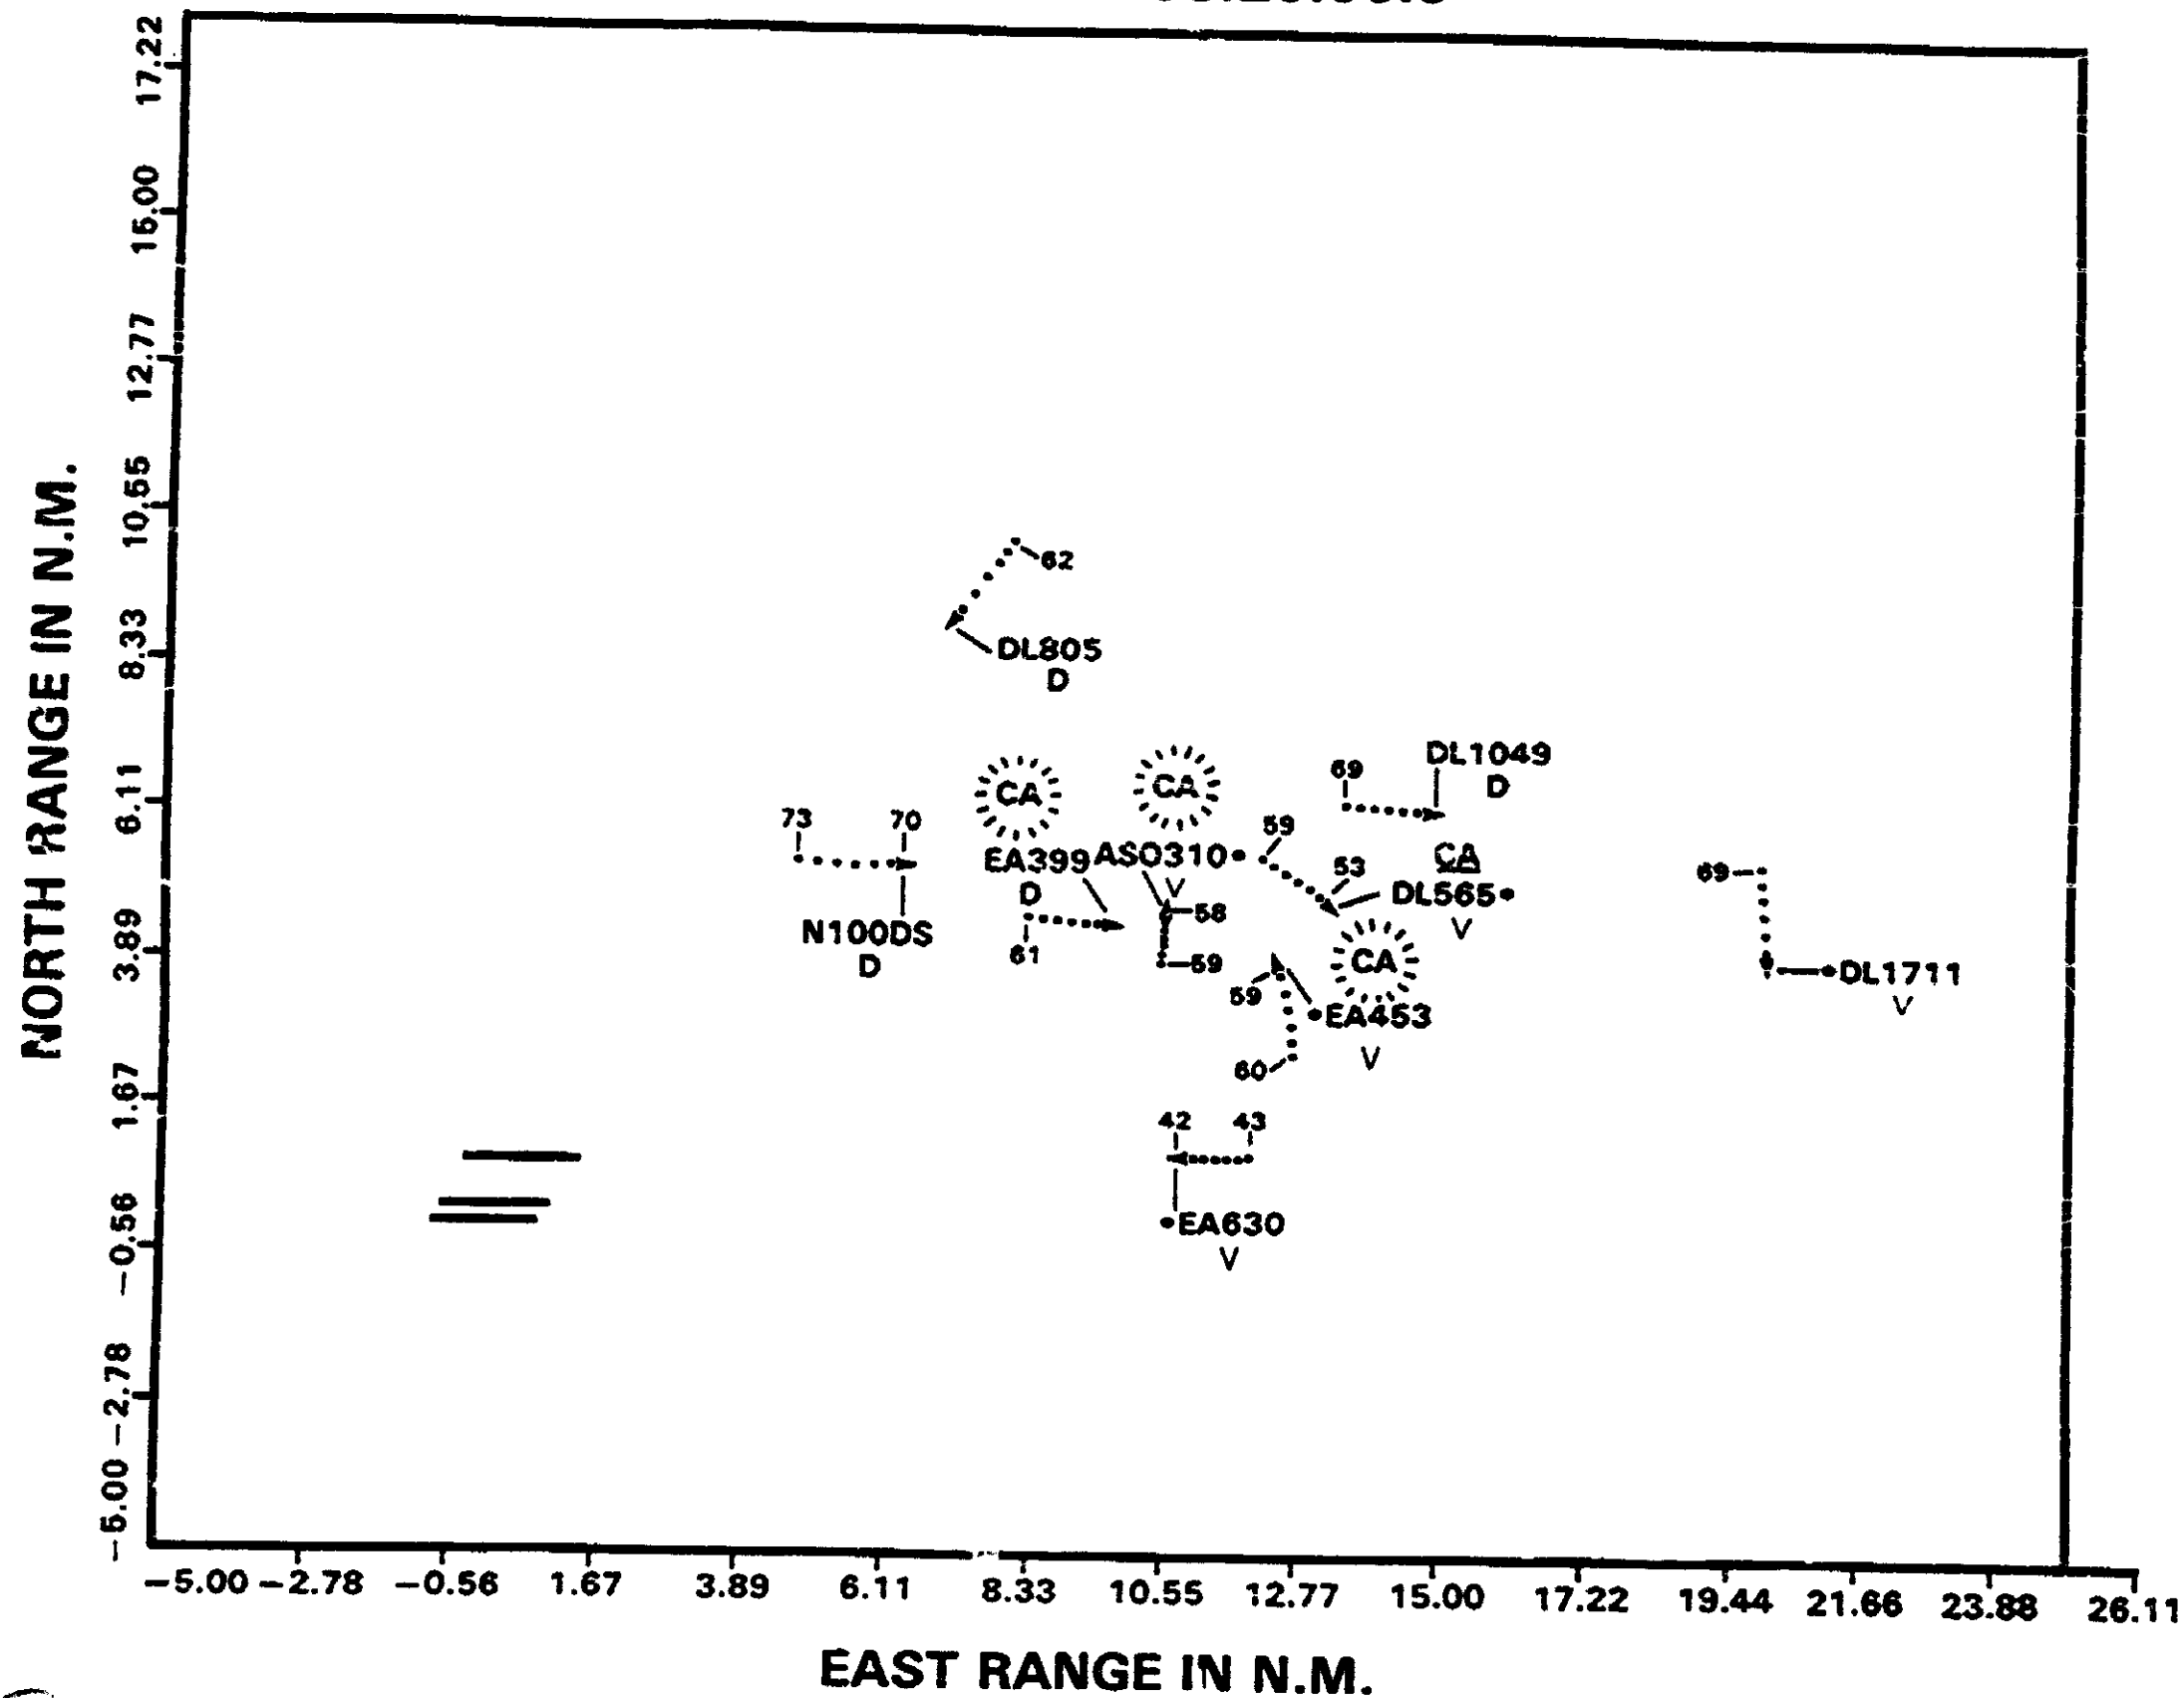
08:19:30.0-08:20:00.0

The data blocks associated with EA453 and ASO301 were not presented on the feeder controller's scope for the same reasons mentioned above for DL565.

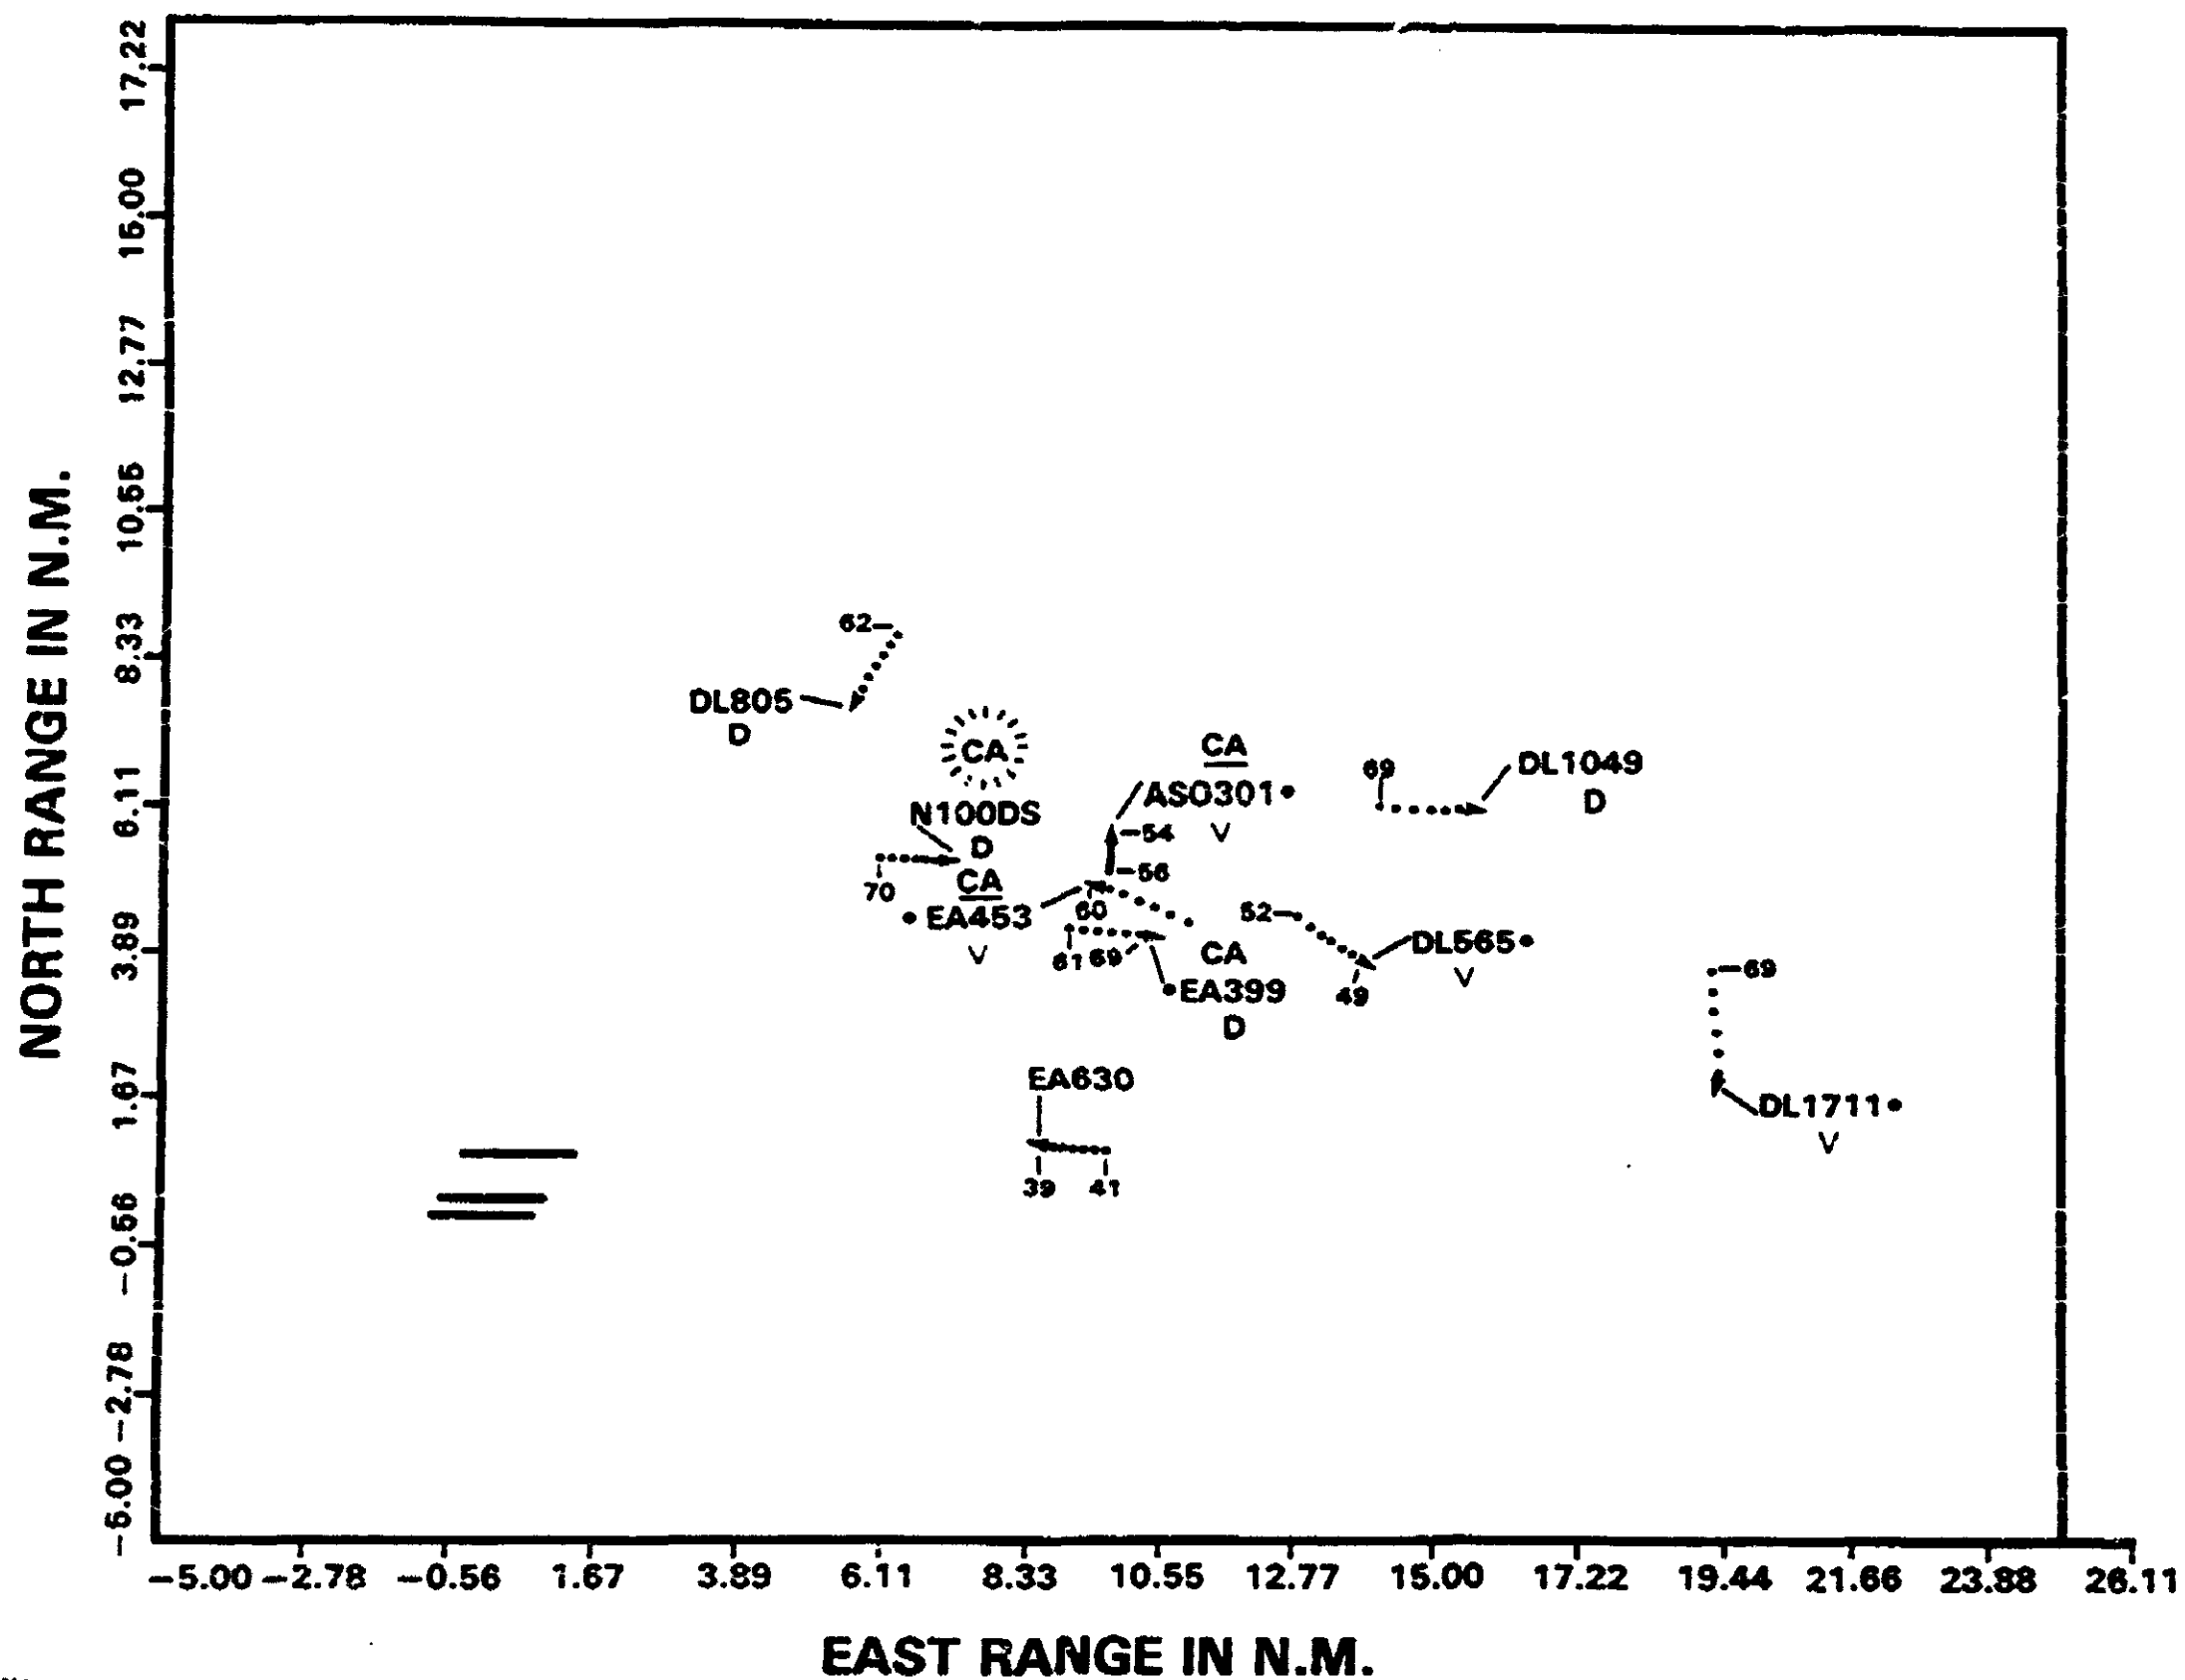
08:20:00.0-08:20:30.0

On the feeder controller's frequency, when instructed to climb, EA 399 replied "Well that ain't gonna help that he's already past me. Then at 0820:14, EA399 told the feeder controller, "there's two of them in fact." EA 399 was then instructed to climb to 7,000 ft.

During this time period, the conflict alert activates on N100DS, stops on ASO 301, and continues on EA399.

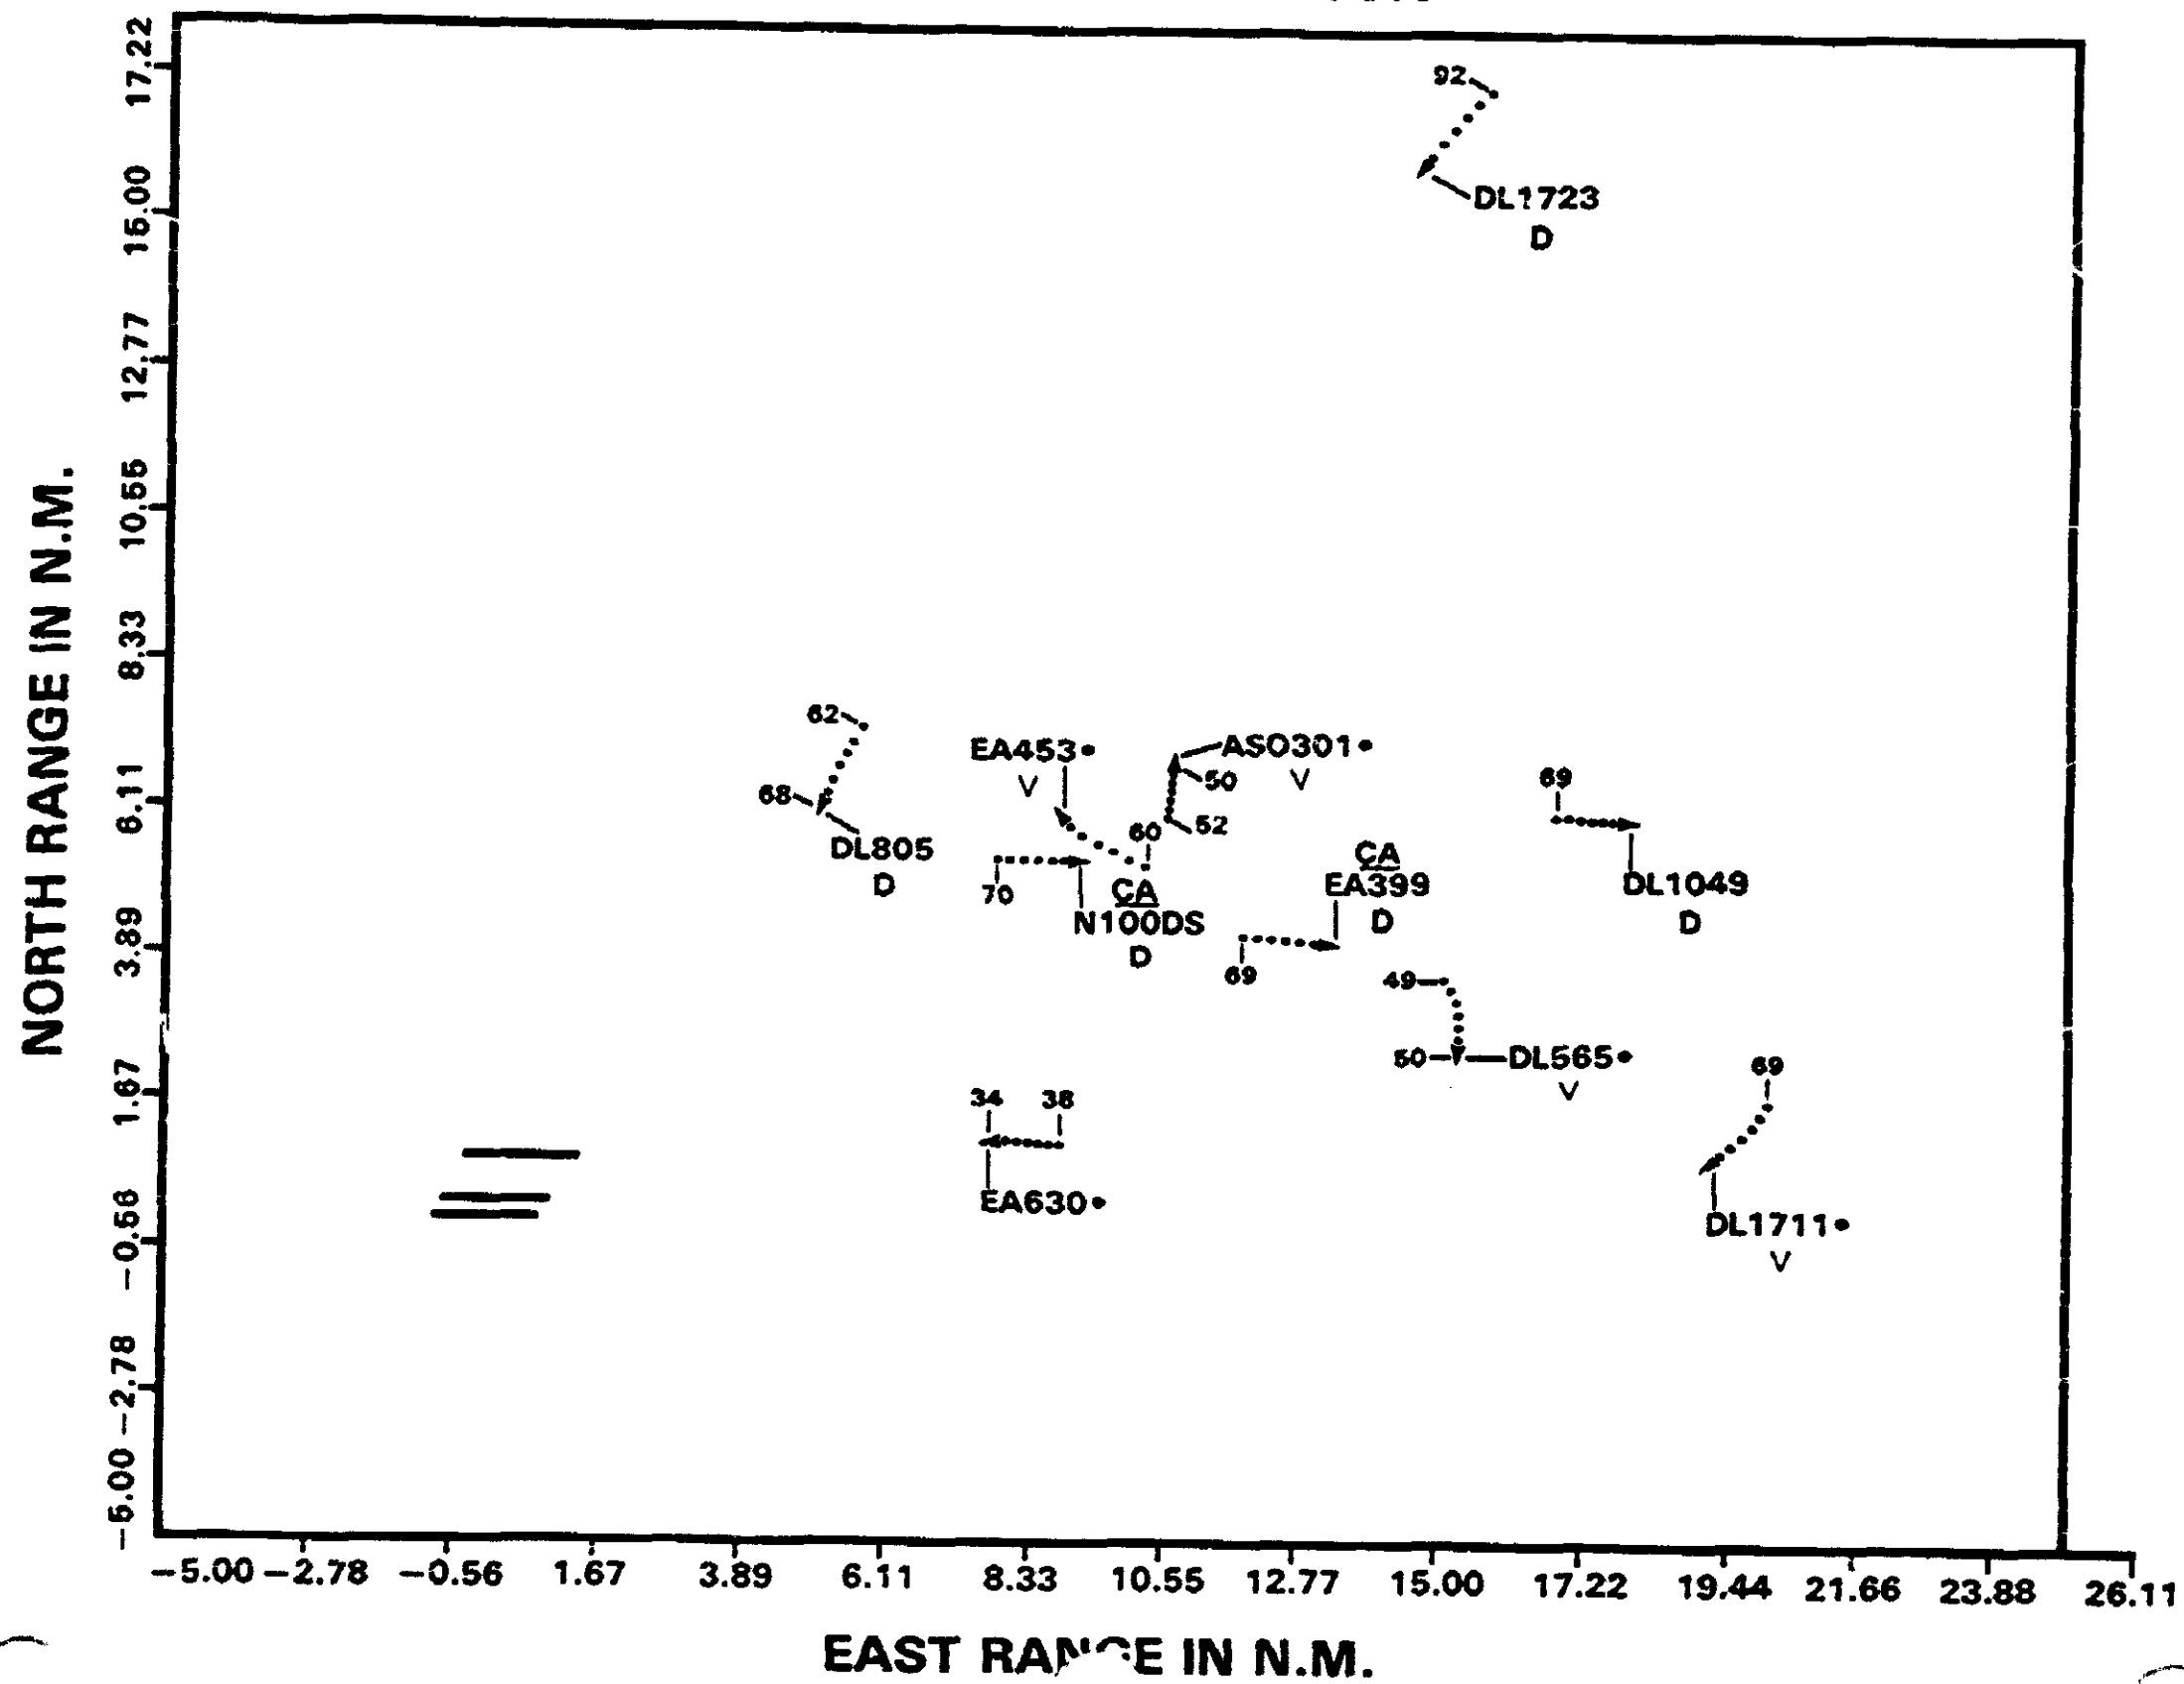
08:20:30.0-08:21:00.0

During this time period ,the
conflict alert stops on
EA399 and N100DS.
